PROJECT MANAGEMENT CHALLENGE 2007

SHARED VOYAGES: LESSONS LEARNED FROM THE EXTERNAL TANK

*How I Found Out That We Are
Not Nearly As Smart As We
Thought We Were*

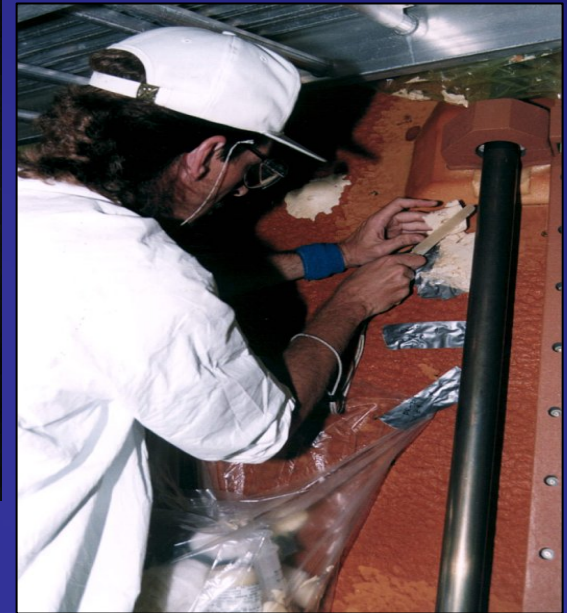
REPAIR OPERATIONS to holes
caused by woodpeckers ON ET
FOR STS-70

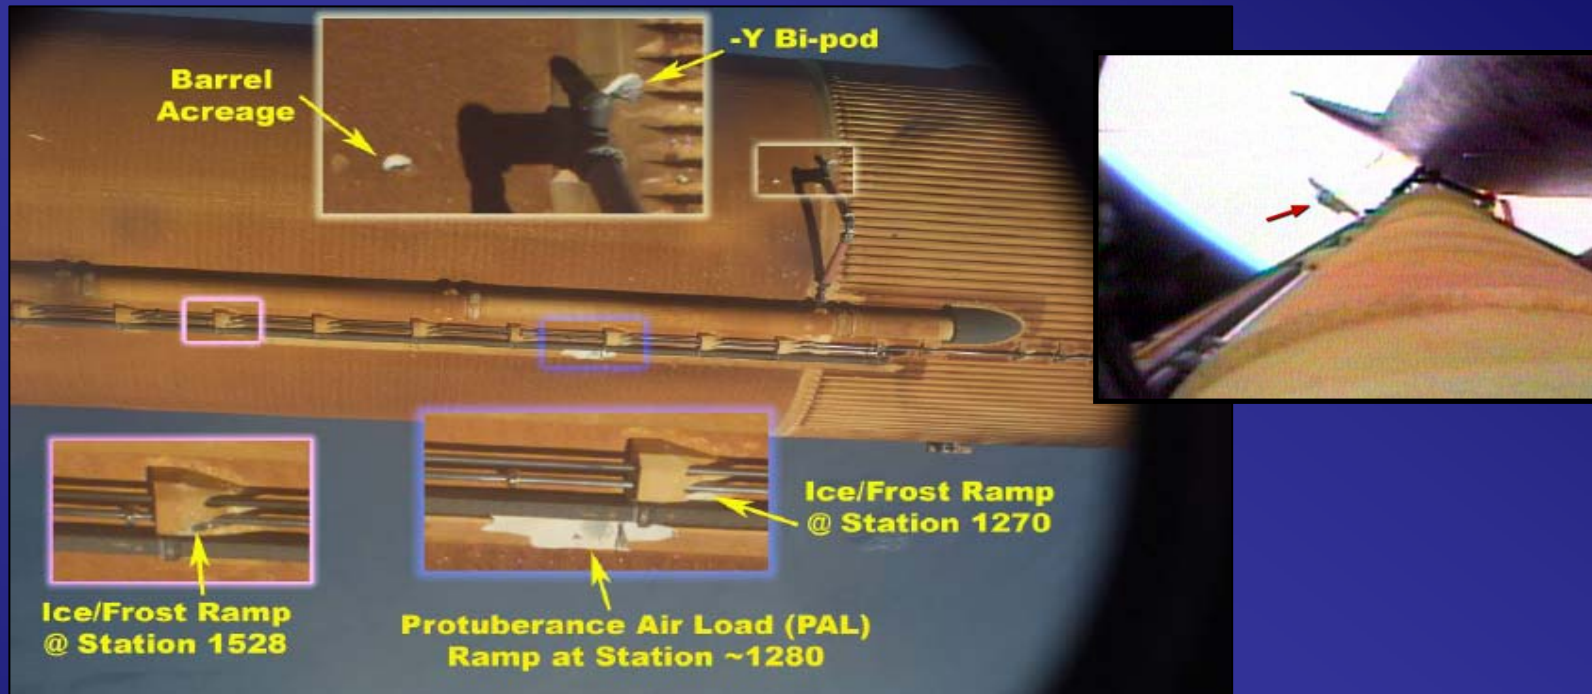
- Major foam loss from Bipod wedge
- Major foam loss from Protuberance Air Load (PAL) ramp
- Significant foam losses around the Ice/Frost Ramps
- Near misses of Orbiter from all three areas could have been catastrophic

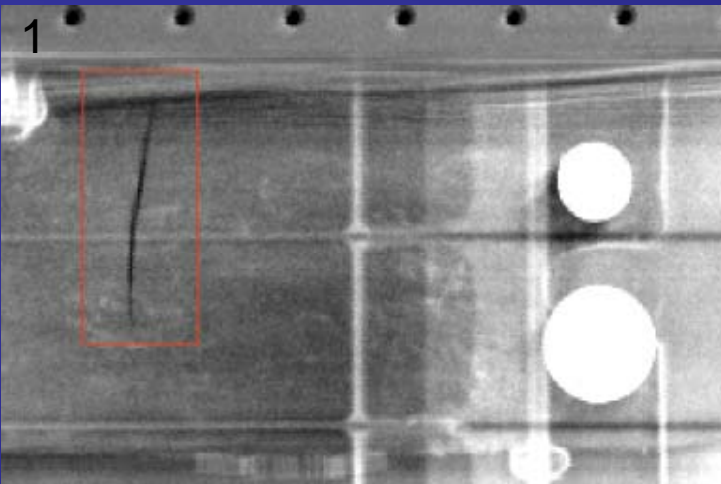
One of the first 2 cracks reported; crack that appears to be closed at the surface; found in zone 5 inspection

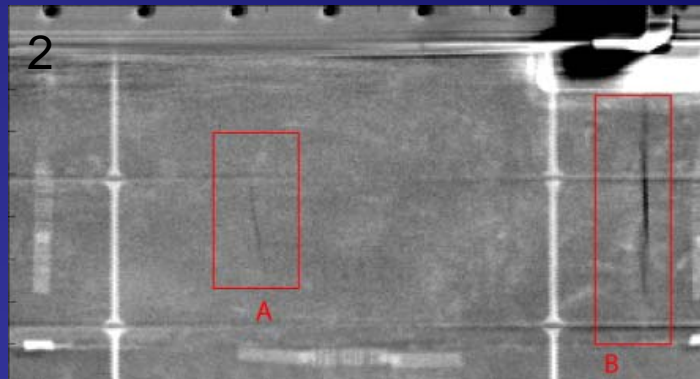
B is the second crack reported from visual inspection; A is crack found during backscatter inspection; found in Zone 6 inspection

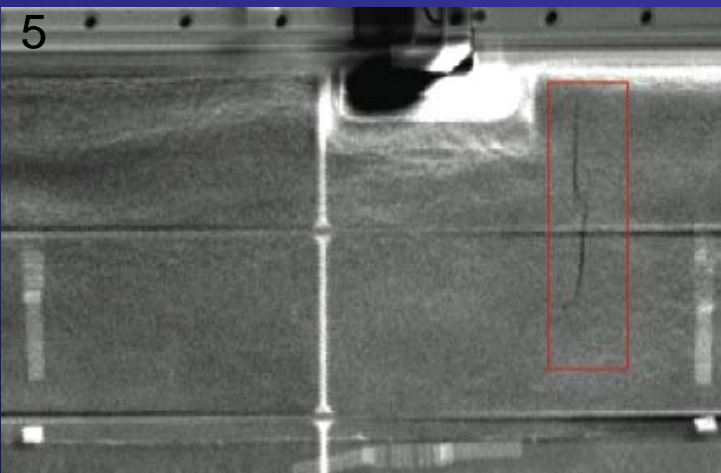
Second crack detected during inspection on 11/3/05; found in zone 14

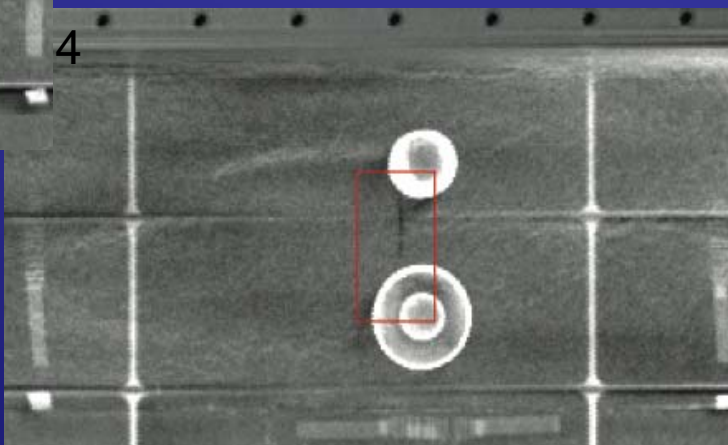
Crack detected during inspection on 11/3/05; appears to run between plugs and under or into the larger plug; found in zone 13

Turns out that the full size (test) article shows there is significant differences in thermal expansion for foam on foam application, which leads to cracks, primarily on the hydrogen tank

The Space Shuttle Program immediately directed the removal of the PAL ramp
